Achieving Quality Intraoral Scans

The quality of your intraoral scans directly impacts the quality of the end product. Because of this, it is necessary that we receive excellent scans. In the event that we receive an unusable file, a new scan will be requested. If a new scan is not submitted, the case will unfortunately be cancelled.

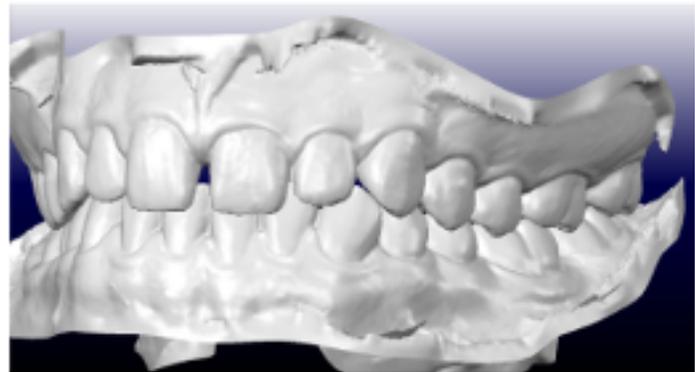
Open Bite

The image on the left shows the maxillary and mandibular arches not in occlusion. This occurs when the 3rd scan of the patient's mouth (occlusion) is not completed. Please make sure to scan a third time (after first scanning the upper and then the lower arches) before submitting your scan to OrthoSelect.

We can do a bite adjustment in these situations, but this takes a fair amount of time. Because it can take a fair amount of time, there is an associated \$15.00 miscellaneous charge per adjustment. Keep in mind that where we place the occlusal bite is an educated guess and may be slightly incorrect.

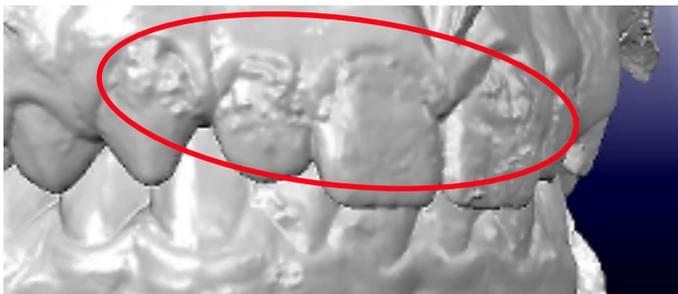
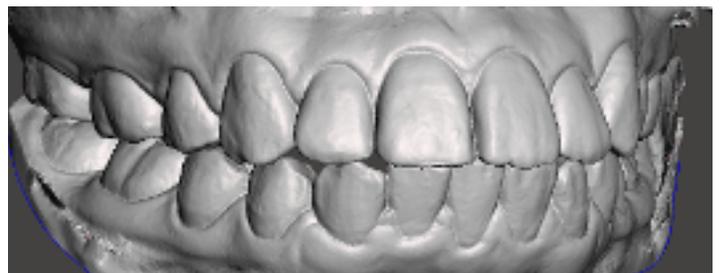
Plaque - Minor cases of plaque are not an issue, but extreme cases of plaque in a scan will prevent a good quality digital model. If ordering appliances, this will affect how the appliance will seat on the patient. To prevent this excess, please have patient's teeth cleaned before taking an intra-oral scan.
